Case Study Data Form

Identifier/name **PW**

Place (town if possible) **Bicester**

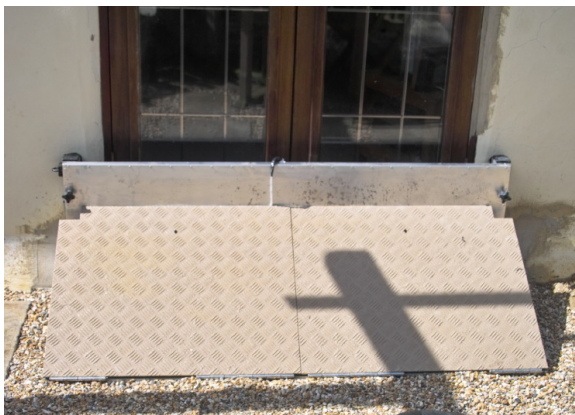
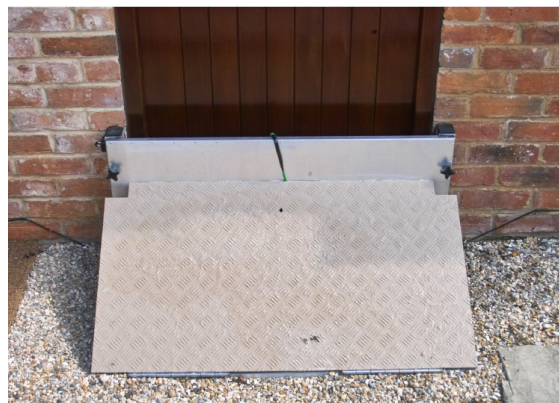
After

Resilient measures installed - **System was installed which included NRV's to the WC and sink waste, sump with automatic pump, lift off door barriers to doors.**

Tested by flooding? **Yes but water came in through walls as the flood was prolonged and client did not take our advice to do the walls as well.**

Any important additional information **The property flooded again in 2008 and was more prolonged than the 2007 flood and the client paid for us to upgrade the system to include the walls of the property at an additional cost of £12k.**
